New wood pole found to be broken at the top

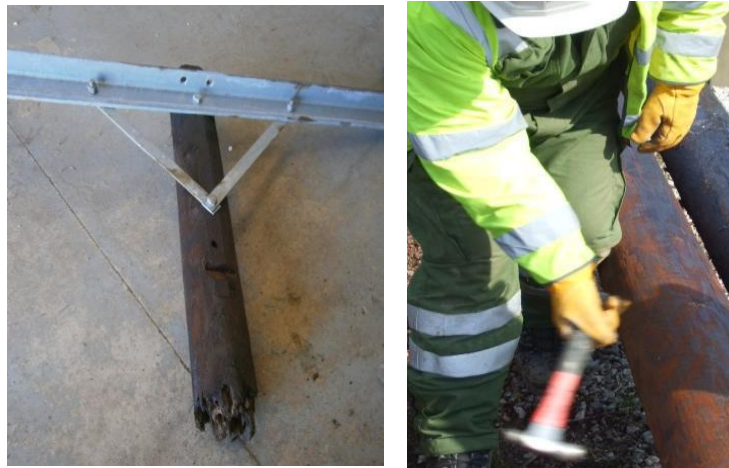
As the linesman started to climb the new pole he became concerned about its integrity and immediately came down. The line team removed the new pole and inspected it more closely when it was on the ground. During this inspection the top section of the new pole split and came away from the remainder of the pole. The pole was removed from site and an investigation is currently being carried out.

Along with the well documented generic recommendations below it would be good practice, where a new pole is to be installed, to carry out a thorough visual inspection and a hammer test prior to a new pole being dressed and erected.

1. Prior to climbing or working on wood poles, carry out a visual inspection and hammer test to verify the condition of the pole and confirm it is safe to access
2. No pole impaired by decay or damage should be climbed
3. Before working at height ensure that the hierarchy of controls are fully considered on all occasions
