Health & Safety

Toolbox Talk

LV flashover – lopping head damages insulation

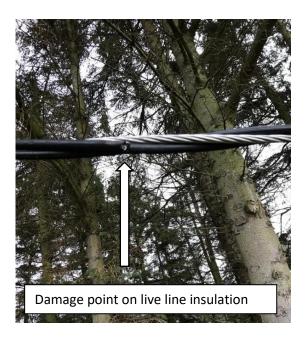
The operator had fitted the lopping head to the top rod and had fitted 5 intermediate rods, he was resting the insulated rod set against the low voltage overhead line bundle. As he lifted up the 5-rod set to fit an additional rod with one hand, the pull rope hanging free down the side of the set, snagged, either at the pull rope insulator insert on a Spruce branch, or on the ground.

Reconstruction photo (using a section of blue rope) showing rods being assembled leaning against the overhead power line.

The snag caused the operator to lose control of the rod set which slid down the LV bundle it was resting on, the open hook of the

lopping head latched over the line bundle and the cutting blade of the lopping head damaged the insulation of the live line. The metal lopping head formed a circuit between the now exposed live line and the bare earth causing a flash over. A loud bang was heard, and the lopping head blade suffered melt damage.

No lopping head or saw and insulated rod set should be allowed to enter the live zone of any voltage, including insulated lines.

Insulated rods must never be allowed to rest on any overhead powerline, of any voltage, in any circumstance.
