Safety Bulletin

LIVE 11,000 Volt Pole Mounted Substation Falls onto Excavator

Issue date	10 th October2017	Ref. No	UAG057

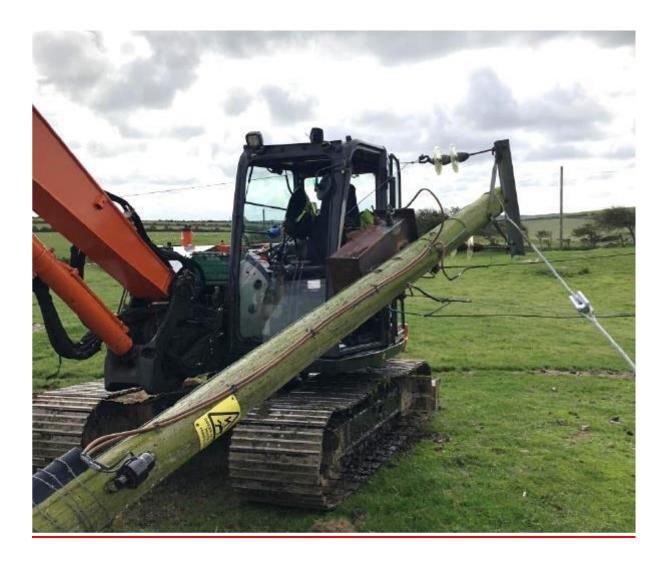
Whilst an excavation was undertaking works at the base of a live 11,000 volt pole mounted substation, the pole became unstable which resulted in the transformer falling into the cab. In addition, the conductors fell across the rear of the excavator.

The excavation was part of the advanced works for a planned HV shutdown. The pole, which in itself did not fail, fell narrowly missing the cab, but the transformer trapped the operator inside.

The 11kV main line protection carried out its full auto-reclose sequence and lockedout with the operator being trapped inside the cab. Whilst this was a significant incident with potentially fatal consequences, miraculously the operator received no injuries.

Guidance for pole excavations are provided by your local DNO. You should find detail of this in **Excavation and Reinstatement Requirements for Pole and Stay Holes.** Ensure these safety requirements are applied, followed and understood prior to setting teams to work. Please also ensure you hold the correct relevant current authorisations.

When any excavation work adjacent to poles is planned or taking place and you have any doubts, concerns or issues about the condition of either the pole, the stay rod or the tension on the line then **STOP** and contact your Team Leader or Supervisor.
