## Failure of Primary HV Overhead Line Earth

Issue date	18 <sup>th</sup> December 2015	Ref. No	UAG037
------------	--------------------------------	---------	--------

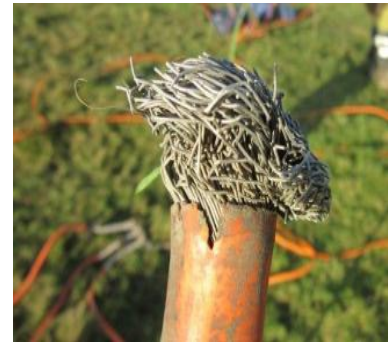
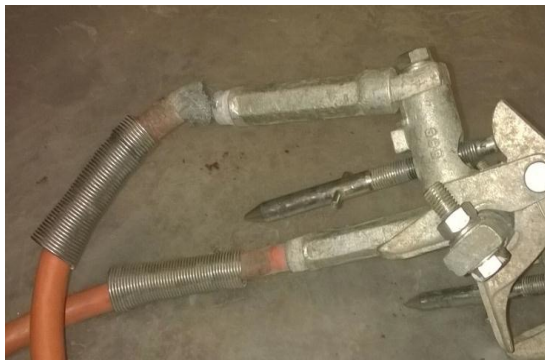
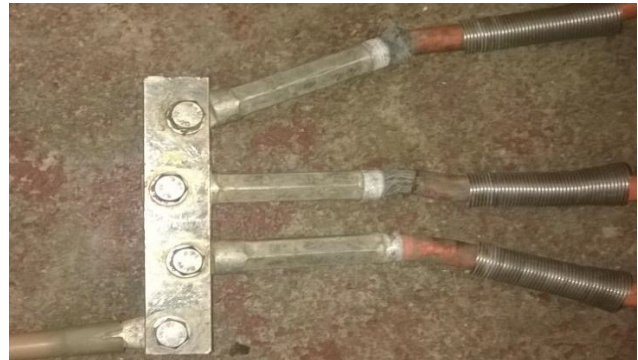
A UK based Network Operator has recently reported a jointer received a mild electric shock while removing lead from a 33kV cable. The faulty section of cable had been cut away and he was working on the side connected to an overhead line that supplied two primary substations. After he received the shock he checked the portable Primary HV earth and found that one of the connections to the conductor clamps had broken. He immediately informed the Permit holder and work was stopped, the SAP and the Control person were notified and the defective earth was replaced and recovered safely allowing work to continue.

Closer inspection of the defective portable Primary HV earth found that the insulation and conductors were damaged under the sprung coil shrouds at another three positions. The earths were included in a formal inspection regime, and their next inspection due date was April 2016.

Ensure all portable earths are included in a formal periodic inspection regime in line with your own Company policy and the manufacturer guidelines.

Ensure all portable earths are subject to a thorough visual inspection before they are used, checking the integrity and function of all clamps, leads and connections.

Ensure any defective portable earth is not used, immediately withdrawn from service, and reported to your Site Supervisor or Line Manager.
