## Reports on Phase to Phase contact events that caused outages

Two events have been recently reported where tree branches have made contact with Live Conductors causing a Phase to Phase contact resulting in an outage. One involved branches being pruned of trees on LV circuits and one where a small tree was being felled adjacent to an 11Kv circuit.

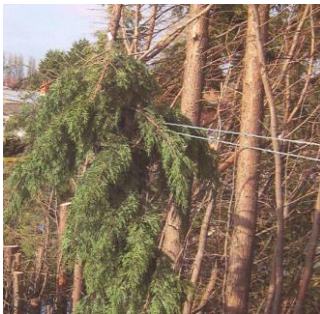
**The Event:** A Certificated and Authorised work team reducing a cypress hedge with the circuit Live. The operator of the MEWP used a Sliky saw to cut a step cut into the stem. He attempted to lift the stem by holding it and moving the MEWP bucket. It got caught up and he lost his grip and it fell onto the LV line causing Phase to Phase contact and a loss of supply. There were no injuries.

**The Learning:** Most of the work had been completed under a shutdown and the risk assessment to complete this section Live was not in place. The work method was not an approved technique and put operators and the circuit at risk. Completing the work while the circuit was de-energised, or, use of insulated equipment and cutting smaller sections would have allowed the work to be completed safely. Re-training of staff was completed and a safety briefing completed with all work teams

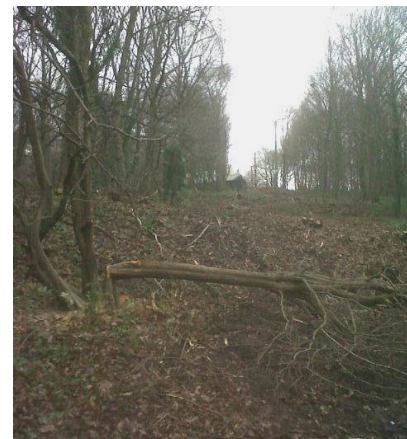
**The Event:** While pruning and removing small trees adjacent to an 11Kv overhead line on a gusty day a Utility certificated ground-based chainsaw operator decided to fell a small stem. He did not communicate this decision to other team members and did not employ any assisted felling techniques. The felling cut was completed to a very poor standard and the small and uneven hinge snapped. The tree fell towards the line and brushed the conductors causing a phase to phase contact and a line breakage. There were no Injuries.

**The Learning:** The operator did not follow the site rules by not communicating with the site supervisor. There is no reason to rush into completing work without agreement of site staff and following the planned sequence of work.

The operator is to be fully re-trained and re-assessed. A safety brief has been completed with all working teams
